Celine Nakachi  
 Professor Hana Bottger  
 Architecture 398  
 14 August 2015

### Restoration Efforts Following the Nepal Earthquake

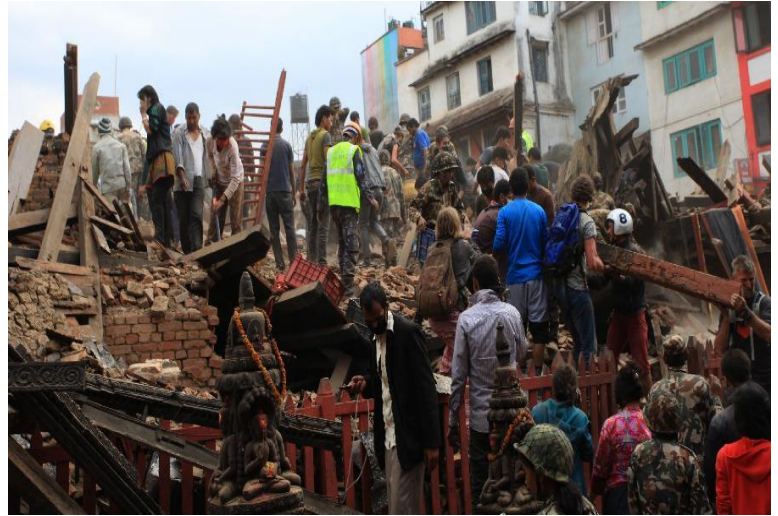
**Failure/Damage Observation:** The main structure has completely collapsed. The wooden parts of the structure seemed to have failed where longer, extended wooden posts or beams were, mainly towards

their middles. It is apparent also that the wooden structures seemed to have failed at their ground connections as well because as you can see, a lot of the wooden elements are lifted out of their supports. The temple’s main connections consisted of wooden joinery, and very few joints/connections are still visibly intact. The shorter wooden compositions seemed to survive (such as the red picket fence in the front.)

Figure 4 Kasthamandap, in the aftermath of the earthquake (9)

Nepal's construction methods are poor. Construction of the Kasthamandap Temple consisted of mostly wood, without the use of nails or any other metal fasteners but rather its structure relied on elegant wooden joinery. It is possible that for centuries, this structure has stood due to these techniques. Wood is a strong structural material as it has the capacity to bend and withstand heavy forces, and it is not brittle. However, a clear suggestion that I have if the temple is rebuilt would be that they use nails, rivets, and other "ductility fuses". To retain the temple's historical value, I would suggest that the elegant joinery remain.

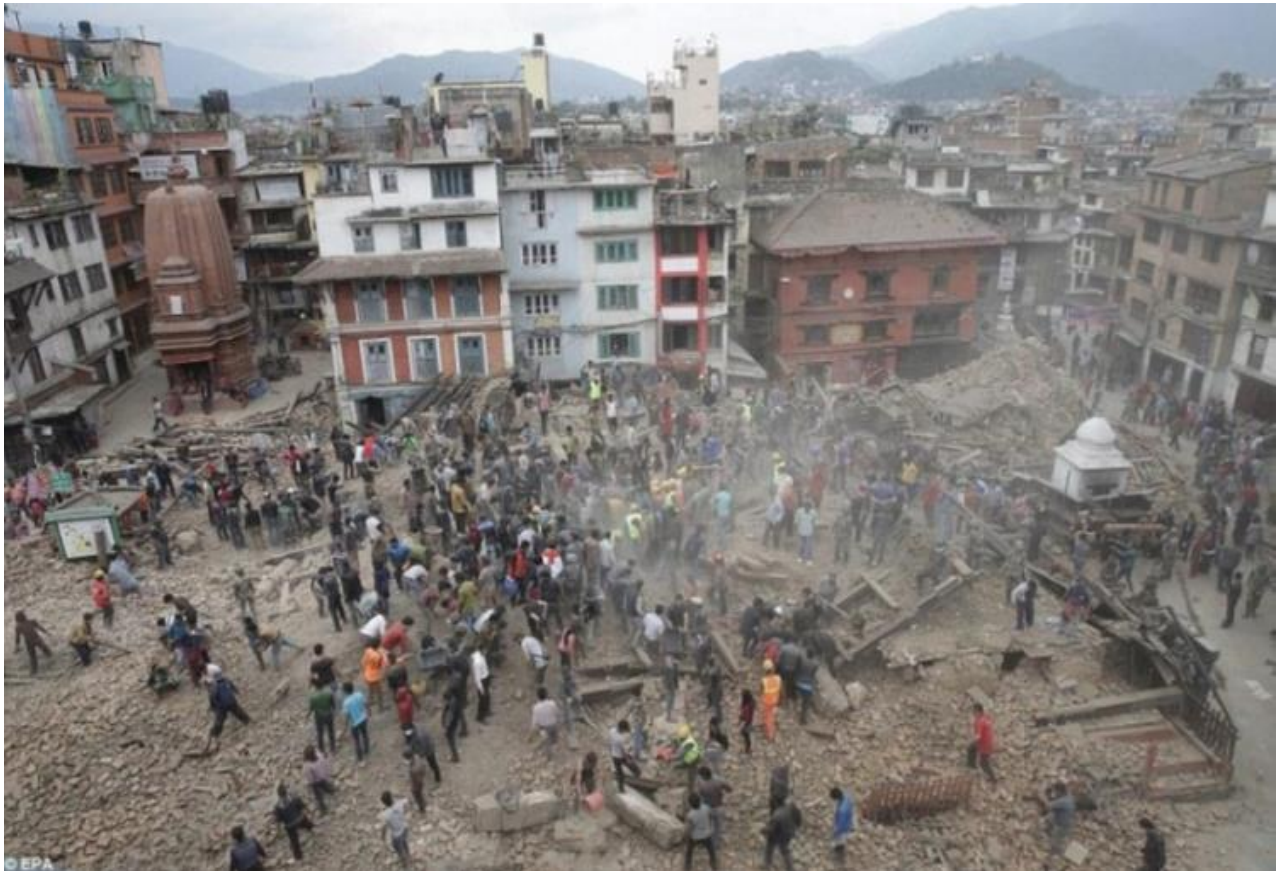
Figure 5 Kasthamandap's destruction, from an above view (10)

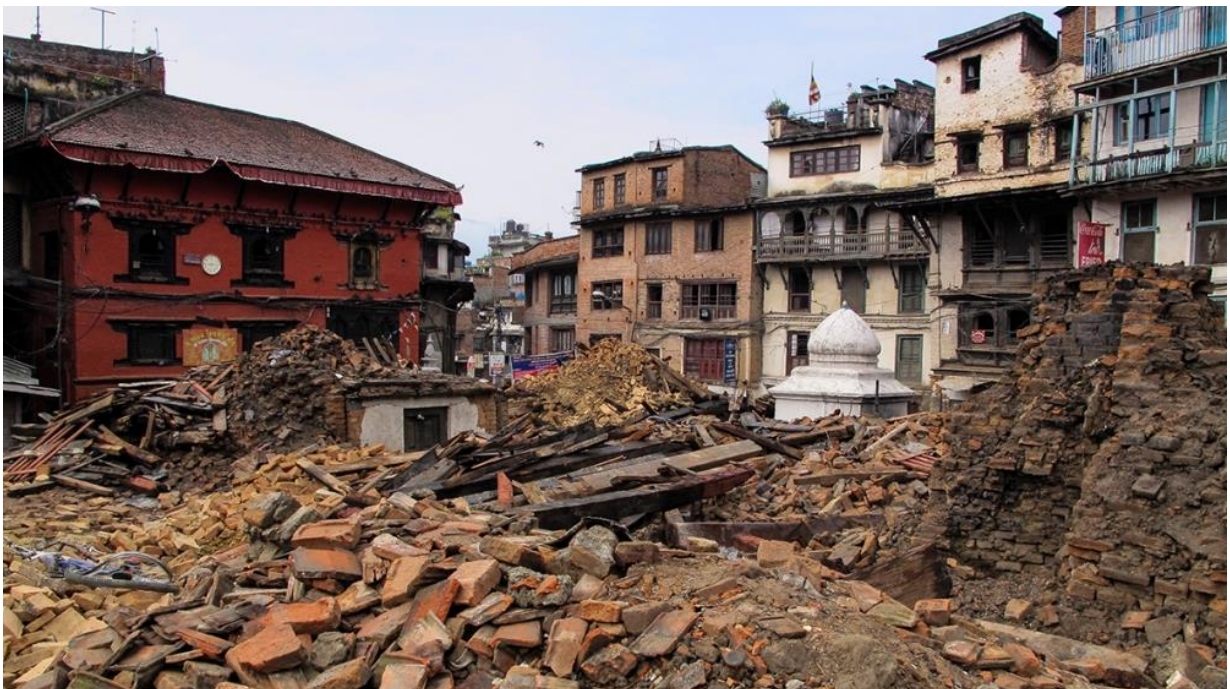
**Failure/Damage:** Brick, stone masonry and concrete material tend to fail easily under earthquake forces due to weakness when subjected to tensile stress. The reason is because masonry as a construction method is a brittle system. Materials used in brittle construction systems usually do not deform when they break, nor does the system allow for much deformation among its components. When subjected to lateral forces (such as an earthquake), it will usually crack and /or break in a diagonal direction. In the picture of the brick building after the earthquake, you can see that a lot of the brick units are still in their whole form, however have been detached from the wall with cracks in a diagonal direction. In this situation, the mortar bond that held the bricks together was the weak link. As one may already notice in the before picture of this brick building, the construction quality is already poor. Some bricks in the pattern seem to be missing, and some are even extruding more than others. Proper, quality construction techniques contribute greatly to how it will perform during an earthquake. (31)

Figure 9 Brick building, after the earthquake (12)

To improve brick as a means for construction, I would suggest that more thorough care be taken when building. For example, brick did not seem to be laid out very carefully in construction, and almost looked like each piece was carelessly thrown into place. The techniques of carefully laying brick with thin mortar joints and carefully "pointing" can lead to a much stronger bond and overall wall system. When rebuilding, brick can be reinforced by incorporating "joint reinforcement." Joint reinforcement consists of thin steel bars that run horizontally between courses of bricks and are shaped like long, flat "H's." If a structure is already built with brick, exterior mesh can be added. During restoration in Indonesia, also a relatively poor country, houses were built to be earthquake-resistant with the use of steel reinforcement between brick, and maybe Nepal construction restoration can follow this technique. (31)

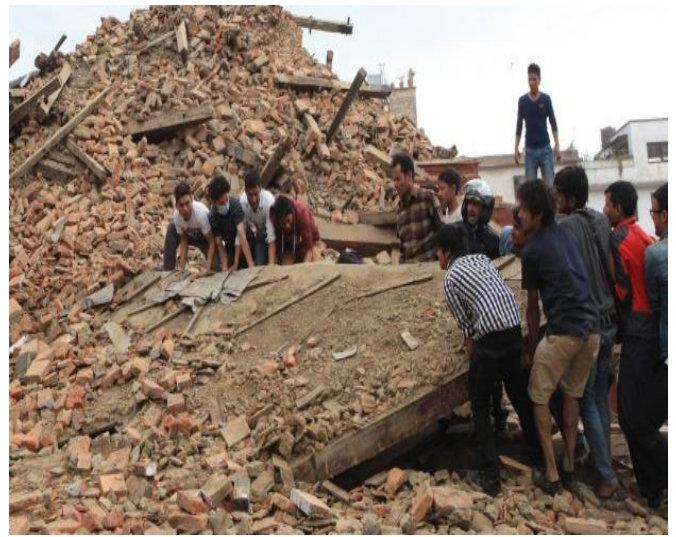
**Failure/damage:** As mentioned before, brick tends to fail easily in earthquake situations. However, looking at the Hanumandhoka Temple, failures were both in the brick and the timber framing. As you can see, wooden posts and beams have been broken at the joints and most of the individual bricks are still intact. This implies that the mortar or the bond between the bricks was the weak part of the structure. There are some bricks that seem to have cracked a bit and not in its full shape.

Figure 11 Hanumandhoka destruction from earthquake (16)

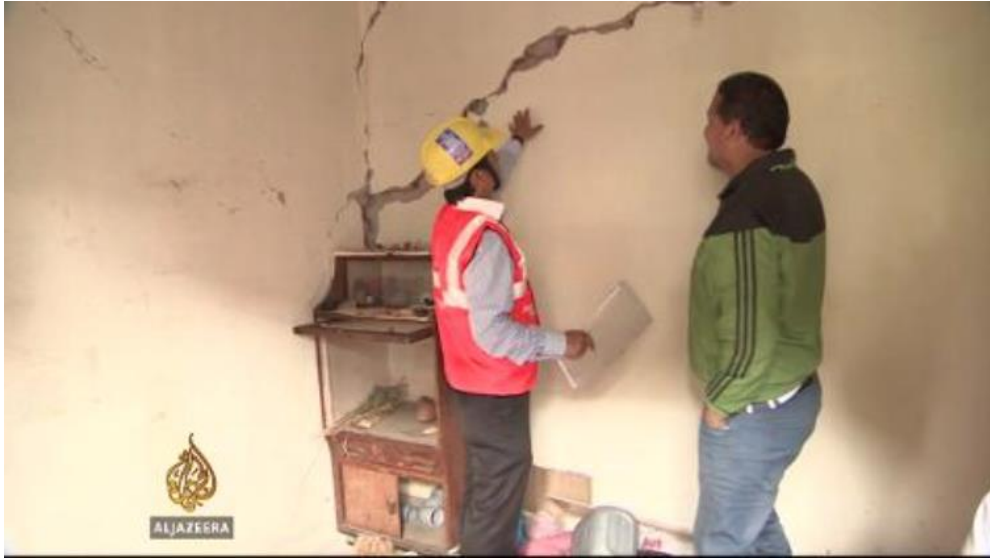
**Failure/damage observation:** In Nepal, construction does not seem to incorporate techniques for strong and well reinforced concrete. (19) As a result, when they build with concrete, they do not properly prepare the molds, and do not leave space for any other crucial structural materials such as steel reinforcing bars. However, in the “newer” (built in late 1970s) concrete buildings of Kathmandu, rebar has been used quite frequently in construction, but it is not clear how much oversight or code enforcement exists to make sure the rebar is placed properly. Today, about only 40% of Kathmandu is constructed with the use of reinforced concrete. Unfortunately, many of the older (built before the 1970s) concrete buildings are built with the absence of rebar, causing those buildings to fail much more readily than others. (18) Concrete is a brittle material, so as you can see in figures 14,15 and 16, when exposed to high-stress situations, concrete will crack where most of the pressure is and crumble into tiny pieces, without deformation. An earthquake as a lateral load shifts the ground in a certain direction. For example if the earthquake moved the ground to the left, due to inertia, a structure tends to stay to the right, causing its bottom left and top right corners to move into tension, and the opposite corners fall into compression. (See brick diagram, figure 8) In figure 15, you can really see the direction in which the earthquake shifted these buildings.

Figure 14 **Interior of a damaged concrete building.** Here, you can see clearly the direction in which the earthquake caused the crack to travel. (12)

An obvious way that concrete as a structural system can be improved is through greater and well-placed reinforcement, because with a strong enough earthquake, even reinforced concrete buildings may fail. Crucial structural concrete elements such as columns SHOULD contain plenty of rebar. Rebar being within a column can be much, much stronger and safer than a column that is purely made of concrete. It would be similar to a leaf with no veins, the shape would still be there, but when subjected to force, it could crumble easily. As mentioned earlier, some of the newer concrete buildings in Nepal already contain reinforcement, and now is a chance to rebuild all with reinforcement. Another suggestion for concrete buildings would be to not build so high up. Since they tend to build upwards in Nepal, it is easier for buildings to topple over during an earthquake. If buildings were lower to the ground, there would be more stability, causing fewer buildings to fall over.

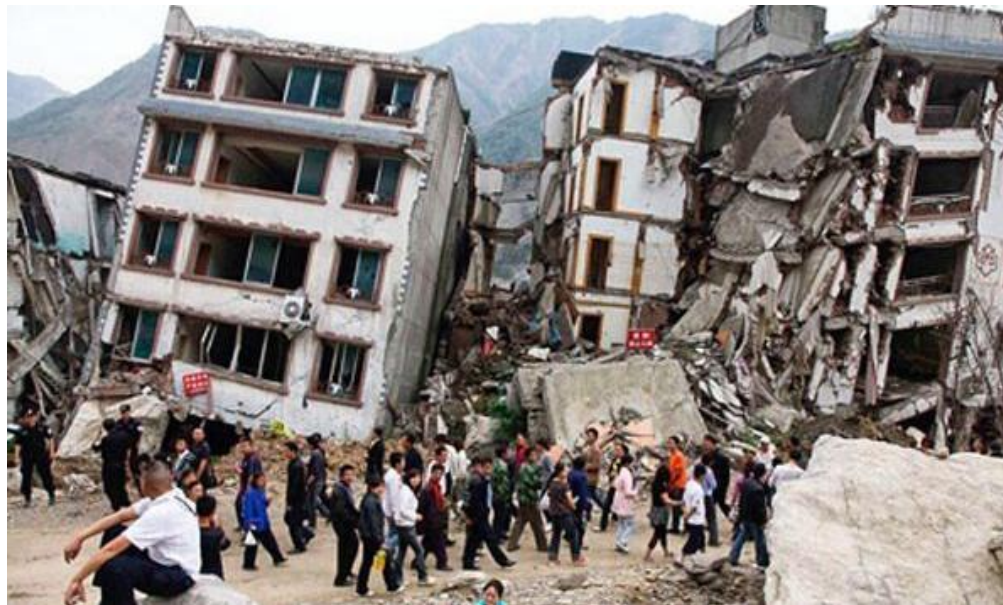
Figure 15 **Damage to concrete buildings after earthquake** (20)

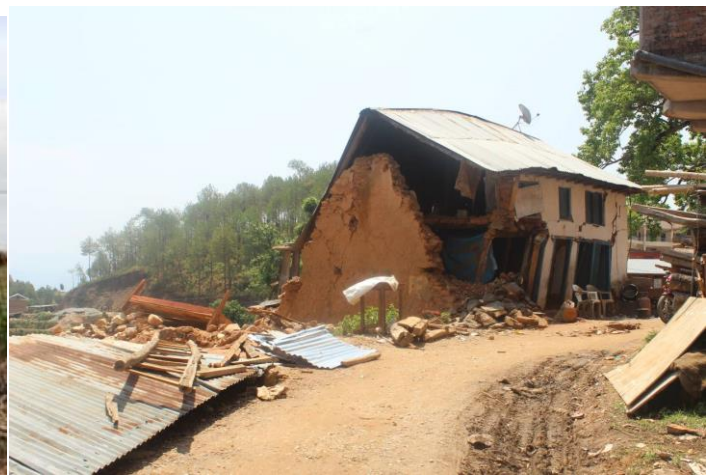
**Failure/damage observation:** Adobe when constructed to resist earthquake forces will have some reinforcement within the walls. It is apparent that in Nepal, there is no structural reinforcement since the walls seemed to have crumbled to the ground, as it is another brittle material. The before (fig 17) and after (fig 18) pictures of the adobe house are not the same house. It is crucial to note the difference between the materials of the two roofs depicted. In the first, a much heavier roof seems to be made of brick and in the second, a lighter, metal corrugated roof, with damage to the house that was not as bad as it could have been with a heavier roof.

Figure 18 Adobe house after earthquake (23)

If citizens must build with adobe, I would recommend that they keep those houses short, and down to 2 stories max. This is because adobe is very heavy, and if even a single chunk of adobe were to fall on someone, it could very easily injure or even kill him or her. When building, I would keep in mind the amount of weight that will be put on the upper parts of the house. For example, I would keep the roofs light. Building roofs with lighter materials such as corrugated metal or aluminum may keep the damage lower than what potential damage capacity could be.
