Celine Nakachi  
 Professor Hana Bottger  
 Architecture 398  
 14 August 2015

### Restoration Efforts Following the Nepal Earthquake

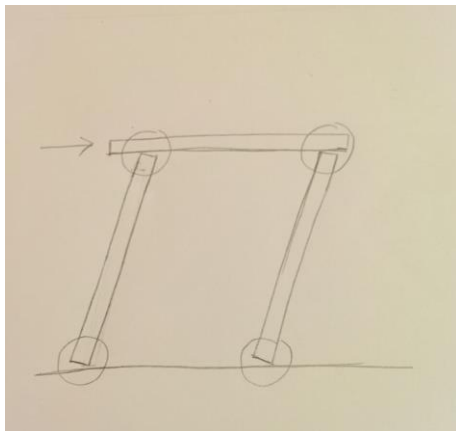
**Failure/Damage Observation:** The main structure has completely collapsed. The wooden parts of the structure seemed to have failed where longer, extended wooden posts or beams were, mainly towards

their middles. It is apparent also that the wooden structures seemed to have failed at their ground connections as well because as you can see, a lot of the wooden elements are lifted out of their supports. The temple’s main connections consisted of wooden joinery, and very few joints/connections are still visibly intact. The shorter wooden compositions seemed to survive (such as the red picket fence in the front.)

Figure 2 **Structural Diagram of Wood during an earthquake.** When a lateral load (left and right force) strikes a wood structure, the connections (joints) are likely to displace, and the vertical elements may break in their centers

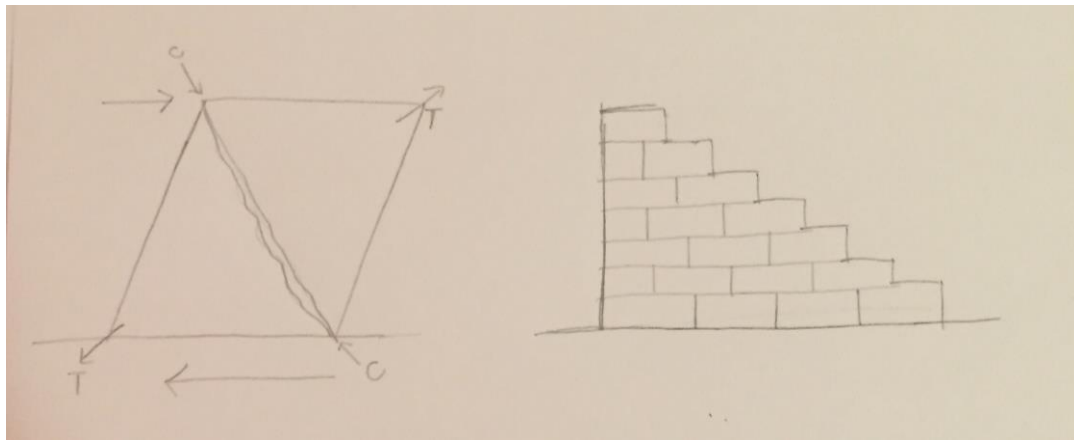
**Failure/Damage:** Brick, stone masonry and concrete material tend to fail easily under earthquake forces due to weakness when subjected to tensile stress. The reason is because masonry as a construction method is a brittle system. Materials used in brittle construction systems usually do not deform when they break, nor does the system allow for much deformation among its components. When subjected to lateral forces (such as an earthquake), it will usually crack and /or break in a diagonal direction. In the picture of the brick building after the earthquake, you can see that a lot of the brick units are still in their whole form, however have been detached from the wall with cracks in a diagonal direction. In this situation, the mortar bond that held the bricks together was the weak link. As one may already notice in the before picture of this brick building, the construction quality is already poor. Some bricks in the pattern seem to be missing, and some are even extruding more than others. Proper, quality construction techniques contribute greatly to how it will perform during an earthquake. (31)

Figure 8 **Structural diagram of how brick will perform during an earthquake.**

The arrow pointing left at the bottom of the diagram shows the ground acceleration, the way that the Earth will shift during the earthquake. The arrow pointing right at the upper left shows the force of the earthquake, the way that the earthquake will tend to push the brick. Arrows labeled “T” show the directions where tension is present, and the arrows labeled “C” show the directions in which compression is present.

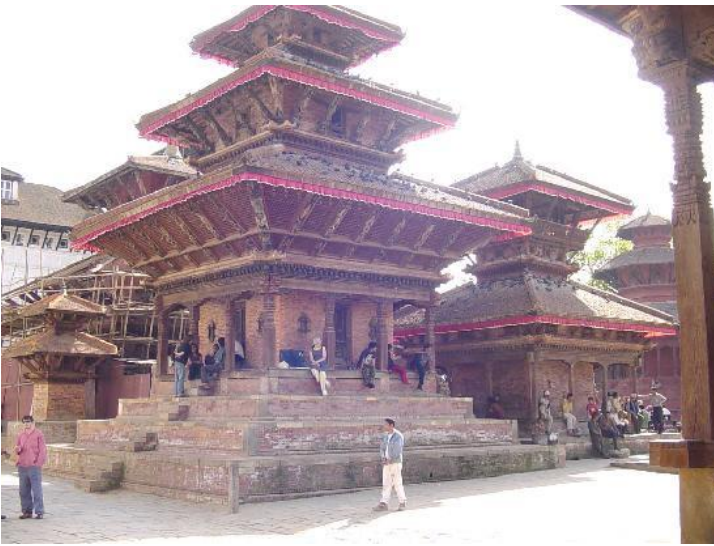
Figure 10 Hanumandhoka as it stood before the earthquake (15)

**Failure/damage:** As mentioned before, brick tends to fail easily in earthquake situations. However, looking at the Hanumandhoka Temple, failures were both in the brick and the timber framing. As you can see, wooden posts and beams have been broken at the joints and most of the individual bricks are still intact. This implies that the mortar or the bond between the bricks was the weak part of the structure. There are some bricks that seem to have cracked a bit and not in its full shape.

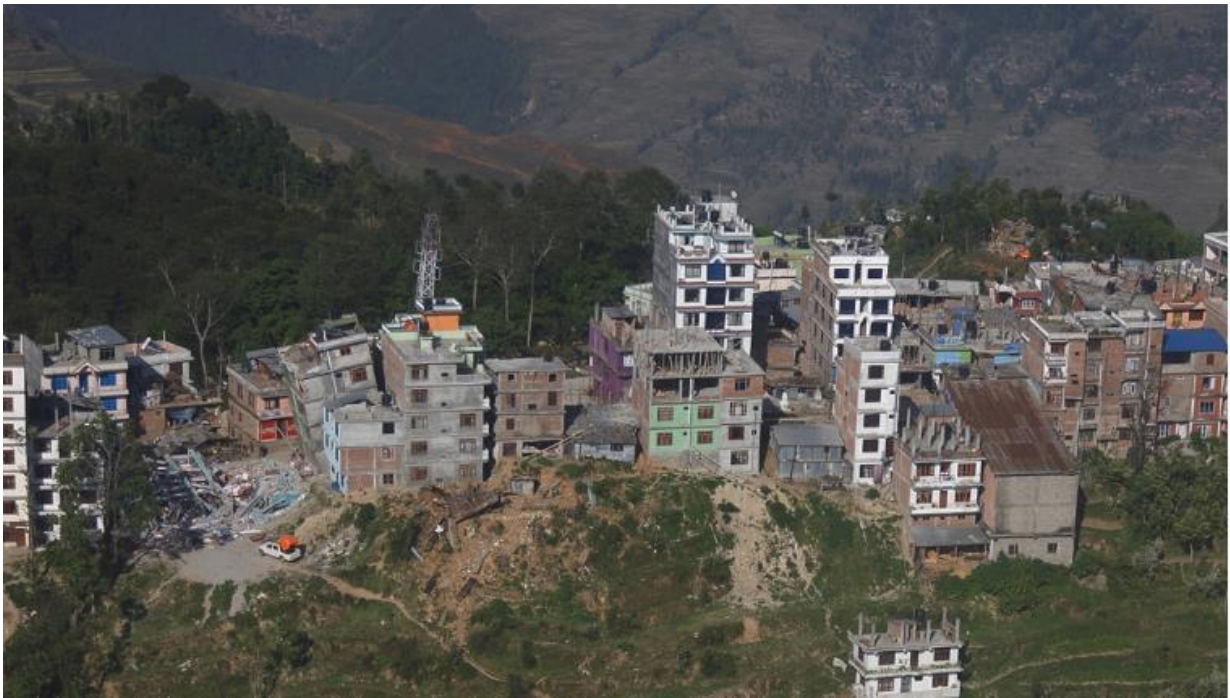
Figure 13: Typical concrete community in Nepal, before the earthquake (12)

**Failure/damage observation:** In Nepal, construction does not seem to incorporate techniques for strong and well reinforced concrete. (19) As a result, when they build with concrete, they do not properly prepare the molds, and do not leave space for any other crucial structural materials such as steel reinforcing bars. However, in the “newer” (built in late 1970s) concrete buildings of Kathmandu, rebar has been used quite frequently in construction, but it is not clear how much oversight or code enforcement exists to make sure the rebar is placed properly. Today, about only 40% of Kathmandu is constructed with the use of reinforced concrete. Unfortunately, many of the older (built before the 1970s) concrete buildings are built with the absence of rebar, causing those buildings to fail much more readily than others. (18) Concrete is a brittle material, so as you can see in figures 14,15 and 16, when exposed to high-stress situations, concrete will crack where most of the pressure is and crumble into tiny pieces, without deformation. An earthquake as a lateral load shifts the ground in a certain direction. For example if the earthquake moved the ground to the left, due to inertia, a structure tends to stay to the right, causing its bottom left and top right corners to move into tension, and the opposite corners fall into compression. (See brick diagram, figure 8) In figure 15, you can really see the direction in which the earthquake shifted these buildings.

An obvious way that concrete as a structural system can be improved is through greater and well-placed reinforcement, because with a strong enough earthquake, even reinforced concrete buildings may fail. Crucial structural concrete elements such as columns SHOULD contain plenty of rebar. Rebar being within a column can be much, much stronger and safer than a column that is purely made of concrete. It would be similar to a leaf with no veins, the shape would still be there, but when subjected to force, it could crumble easily. As mentioned earlier, some of the newer concrete buildings in Nepal already contain reinforcement, and now is a chance to rebuild all with reinforcement. Another suggestion for concrete buildings would be to not build so high up. Since they tend to build upwards in Nepal, it is easier for buildings to topple over during an earthquake. If buildings were lower to the ground, there would be more stability, causing fewer buildings to fall over.

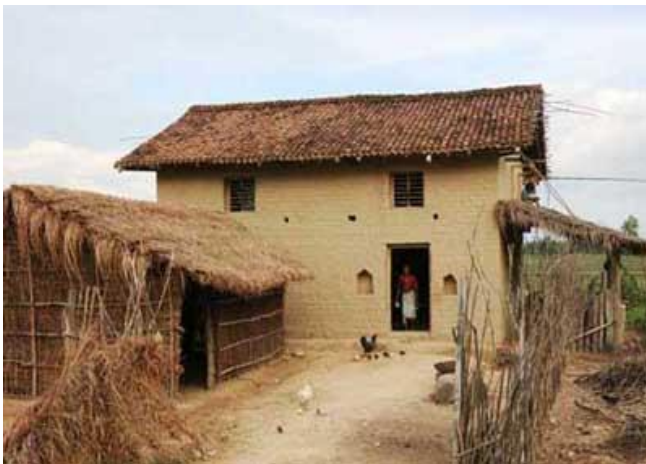
Figure 17 Adobe house before earthquake (22)

**Failure/damage observation:** Adobe when constructed to resist earthquake forces will have some reinforcement within the walls. It is apparent that in Nepal, there is no structural reinforcement since the walls seemed to have crumbled to the ground, as it is another brittle material. The before (fig 17) and after (fig 18) pictures of the adobe house are not the same house. It is crucial to note the difference between the materials of the two roofs depicted. In the first, a much heavier roof seems to be made of brick and in the second, a lighter, metal corrugated roof, with damage to the house that was not as bad as it could have been with a heavier roof.

If citizens must build with adobe, I would recommend that they keep those houses short, and down to 2 stories max. This is because adobe is very heavy, and if even a single chunk of adobe were to fall on someone, it could very easily injure or even kill him or her. When building, I would keep in mind the amount of weight that will be put on the upper parts of the house. For example, I would keep the roofs light. Building roofs with lighter materials such as corrugated metal or aluminum may keep the damage lower than what potential damage capacity could be.

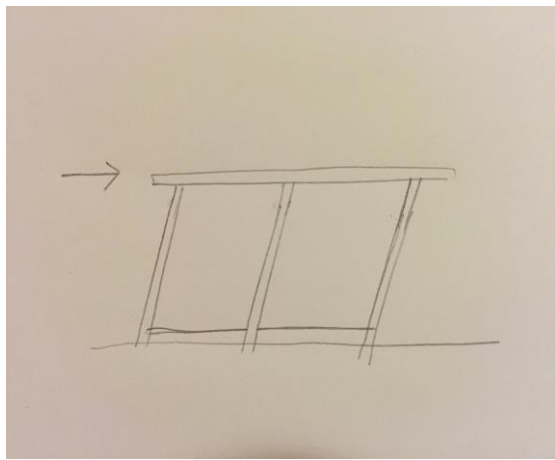
**Failure/Damage Observation:** Bamboo as a material can be very strong. Its hollow center is helpful to its structural ability. I was unable to find pictures of bamboo structures that were affected by the earthquake; this could mean that bamboo structures were possibly not affected by the earthquake because of its strength and flexibility. With bamboo structures, builders receive clear feedback toward obtaining a stable structure by incorporating diagonal members. Diagonal members/cross bracing strongly support a structures stability and load path. The bamboo structure depicted uses diagonal members in both directions so that when the lateral load comes from one direction, one cross-piece will be in tension and the other compression, and vice versa when the load direction is reversed. See figure 25.

Figure 24 **Structural diagram.** Arrows pointing right show motion of the earthquake, and how it will push the bamboo structure.

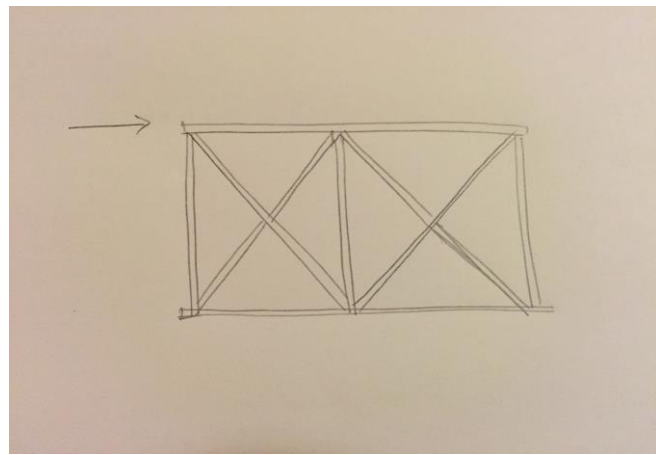
Figure 25 **Structural diagram with diagonal bracing** where lateral forces will not be able to bend the bamboo structure.

Bamboo seems to be an effective structural system, as surmised by the conspicuous lack of information about their failures. I encourage the use of bamboo in areas of Nepal where it is accessible, and for those building in Nepal to always look for ways that they can improve bamboo's structural performance.
